**From:** [Redacted]  
**Sent:** Wednesday, 12 September 2012 4:04 PM  
**To:** [Redacted]  
**Cc:** [Redacted]  
**Subject:** SMR Anatomical Shoulder Prosthesis - New material for consideration prior to 6 pm Monday 17 Septemeber [SEC=UNCLASSIFIED]

# SMR L2 Metal Back Glenoid Component (used in shoulder replacements)—product discontinued

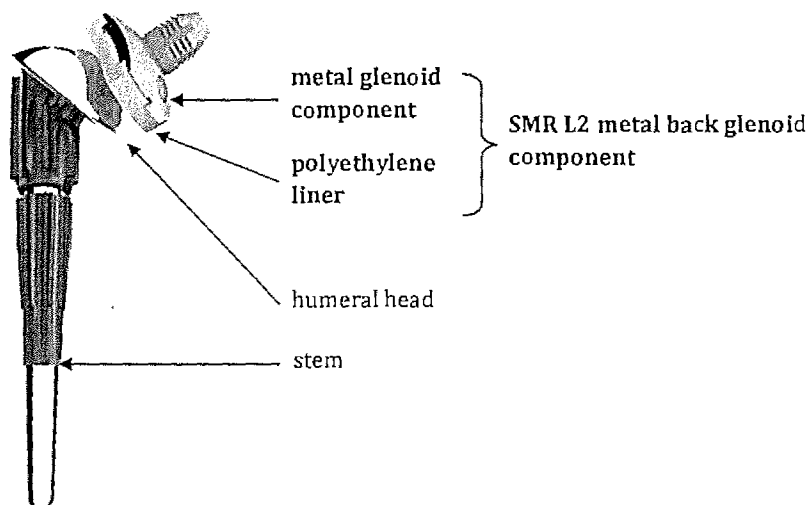
The metal glenoid component and polyethylene liner together comprise the SMR L2 Metal Back Glenoid Component (see diagram below).

The TGA advises health professionals and patients that the SMR L2 Metal Back Glenoid Component has been discontinued. Data collected by the Australian National Joint Replacement Registry (ANJRR) revealed that the SMR had a higher than expected revision rate. The TGA contacted Lima Orthopaedics Australia, whose subsequent investigations revealed that under certain conditions, for example, rotator cuff failure or patient trauma, the SM L2 Metal Back Glenoid Component's polyethylene liner could become detached from the glenoid component, and that this had increased the revision rate of the SMR. As a result, the SMR L2 Metal Back Glenoid Component has been discontinued.

The L2 was introduced in 2009 in response to concerns that the polyethylene liner in the L1 version could wear down and lead to metal-on-metal contact. Subsequently, very few cases of polyethylene wear have actually been observed with the L1 design.

Lima Orthopaedics Australia has monitored the performance of the L2 component since introduction and has found that the total revision rate of the component in Australia is 6.78% at 3 years.

Based on these findings, Lima Orthopaedics Australia is of the view that the L2 liner is not performing as well as the original L1. As a result, only L1 components have been available since 6 August 2012.

Given the nature of the problem, there is no urgent need to contact patients who have received an L2 version of the SMR Metal Back Glenoid Component. However, it is recommended that those patients be followed up according to their routine protocol and advised of this issue at that stage.

If a patient presents with pain, a limited range of motion and/or complaining of a 'squeaking', 'clicking' or 'grinding' sensation at the site of their shoulder replacement, assess the component and follow your established protocols.
