**Fw: Web publishing request - Four joint implant web statements  
[DLM=For-Official-Use-Only]**

In relation to issues with the Apex K2 Modular Hip Replacement System, the Durom Acetabular Component, The Birmingham Hip Modular Head (BHR), and the SMR L2 Metal Back Glenoid Component I, as delegate of the Secretary for the purposes of section 61 of the Act, approve under section 61(7) of the Act the release to the public of the therapeutic goods information relating to these actions as set out below.

# SMR L2 Metal Back Glenoid Component (used in shoulder replacements)—product discontinued

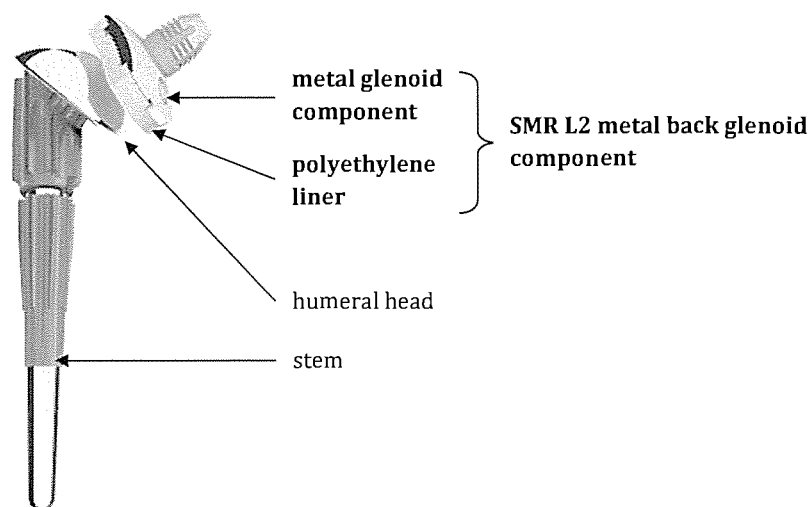
The metal glenoid component and polyethylene liner together comprise the SMR L2 Metal Back Glenoid Component (see diagram below).

The TGA advises health professionals and patients that the SMR L2 Metal Back Glenoid Component has been discontinued. Data collected by the Australian National Joint Replacement Registry (NJRR) revealed that the SMR had a higher than expected revision rate. The TGA contacted Lima Orthopaedics Australia, whose subsequent investigations revealed that under certain conditions, for example: rotator cuff failure or patient trauma, the SM L2 Metal Back Glenoid Component's polyethylene liner could become detached from the glenoid component, and that this had increased the revision rate of the SMR. As a result, the SMR L2 Metal Back Glenoid Component has been discontinued.

Lima Orthopaedics Australia has monitored the performance of the L2 component since introduction and has found that the total revision rate of the component in Australia is 6.78% at 3 years.

Based on these findings, Lima Orthopaedics Australia is of the view that the L2 liner is not performing as well as the original L1. As a result, only L1 components have been available since 6 August 2012.

Given the nature of the problem, there is no urgent need to contact patients who have received an L2 version of the SMR Metal Back Glenoid Component. However, it is recommended that those patients be followed up according to their routine protocol and advised of this issue at that stage.

If a patient presents with pain, a limited range of motion and/or complaining of a 'squeaking', 'clicking' or 'grinding' sensation at the site of their shoulder replacement, assess the component and follow your established protocols.

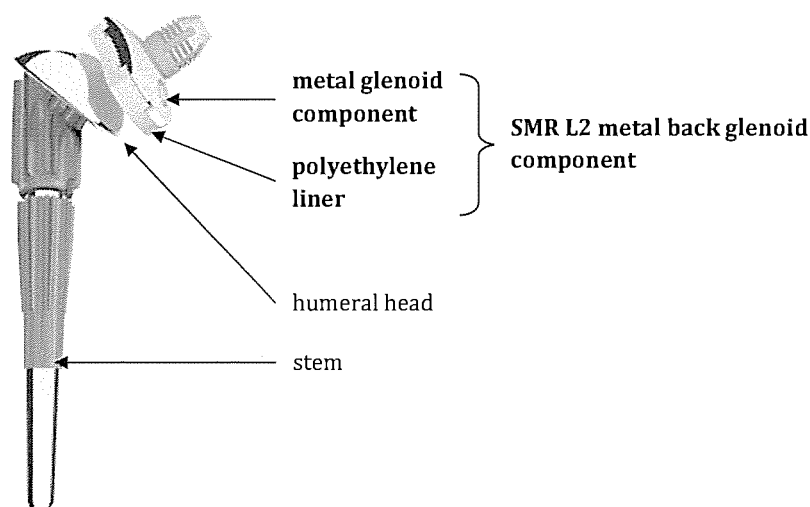
The metal glenoid component and polyethylene liner together comprise the SMR L2 Metal Back Glenoid Component (see diagram below).

The TGA advises health professionals and patients that the SMR L2 Metal Back Glenoid Component has been discontinued. Data collected by the Australian National Joint Replacement Registry (NJRR) revealed that the SMR had a higher than expected revision rate. The TGA contacted Lima Orthopaedics Australia, whose subsequent investigations revealed that under certain conditions, for example: rotator cuff failure or patient trauma, the SM L2 Metal Back Glenoid Component's polyethylene liner could become detached from the glenoid component, and that this had increased the revision rate of the SMR. As a result, the SMR L2 Metal Back Glenoid Component has been discontinued.

Lima Orthopaedics Australia has monitored the performance of the L2 component since introduction and has found that the total revision rate of the component in Australia is 6.78% at 3 years.

Based on these findings, Lima Orthopaedics Australia is of the view that the L2 liner is not performing as well as the original L1. As a result, only L1 components have been available since 6 August 2012.

Given the nature of the problem, there is no urgent need to contact patients who have received an L2 version of the SMR Metal Back Glenoid Component. However, it is recommended that those patients be followed up according to their routine protocol and advised of this issue at that stage.

If a patient presents with pain, a limited range of motion and/or complaining of a 'squeaking', 'clicking' or 'grinding' sensation at the site of their shoulder replacement, assess the component and follow your established protocols.
