SMR L2 Metal Back Glenoid Component (used in shoulder replacements)

Product discontinued

30 October 2012

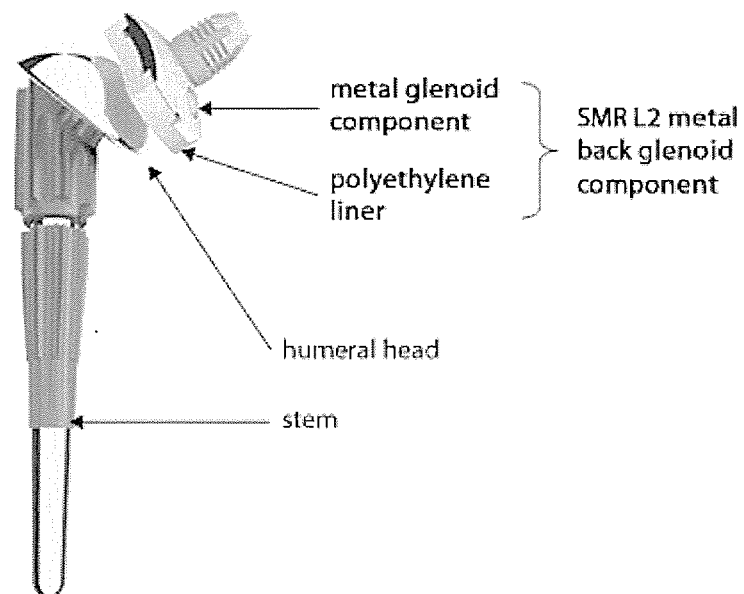
The metal glenoid component and polyethylene liner together comprise the SMR L2 Metal Back Glenoid Component (see diagram below).

The TGA advises health professionals and patients that the SMR L2 Metal Back Glenoid Component has been discontinued. Data collected by the Australian National Joint Replacement Registry (NJRR) revealed that the SMR had a higher than expected revision rate. The TGA contacted Lima Orthopaedics Australia, whose subsequent investigations revealed that under certain conditions, for example: rotator cuff failure or patient trauma, the SM L2 Metal Back Glenoid Component's polyethylene liner could become detached from the glenoid component, and that this had increased the revision rate of the SMR. As a result, the SMR L2 Metal Back Glenoid Component has been discontinued.

The L2 was introduced in 2009 in response to concerns that the polyethylene liner in the L1 version could wear down and lead to metal-on-metal contact. Subsequently, very few cases of polyethylene wear have actually been observed with the L1 design.

Lima Orthopaedics Australia has monitored the performance of the L2 component since introduction and has found that the total revision rate of the component in Australia is 6.78% at 3 years.

Based on these findings, Lima Orthopaedics Australia is of the view that the L2 liner is not performing as well as the original L1. As a result, only L1 components have been available since 6 August 2012.

Given the nature of the problem, there is no urgent need to contact patients who have received an L2 version of the SMR Metal Back Glenoid Component. However, it is recommended that those patients be followed up according to their routine protocol and advised of this issue at that stage.

If a patient presents with pain, a limited range of motion and/or complaining of a 'squeaking', 'clicking' or 'grinding' sensation at the site of their shoulder replacement, assess the component and follow your established protocols.
