From: [REDACTED]
Sent: Wednesday, 12 September 2012 4:04 PM
To: [REDACTED]
Cc: [REDACTED]
Subject: SMR Anatomical Shoulder Prosthesis - New material for consideration prior to 6 pm Monday 17 Septemeber [SEC=UNCLASSIFIED]

SMR L2 Metal Back Glenoid Component (used in shoulder replacements)—product discontinued

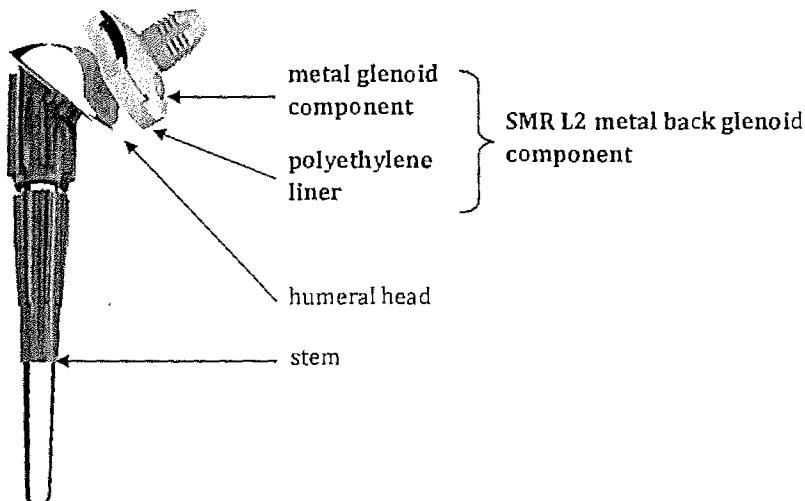
According to Lima, the incidence of dissociation leading to revision for the L2 glenoid is much higher than that of the L1 glenoid. Therefore they have decided to discontinue the supply of the L2 glenoid and liner.

The metal glenoid component and polyethylene liner together comprise the SMR L2 Metal Back Glenoid Component (see diagram below).

The TGA advises health professionals and patients that the SMR L2 Metal Back Glenoid Component has been discontinued. Data collected by the Australian National Joint Replacement Registry (NJRR) revealed that the SMR had a higher than expected revision rate. The TGA contacted Lima Orthopaedics Australia, whose subsequent investigations revealed that under certain conditions, for example, ~~rotator cuff failure or patient trauma~~, the SMR L2 Metal Back Glenoid Component's polyethylene liner could become detached from the glenoid component, and that this had increased the revision rate of the SMR. As a result, the SMR L2 Metal Back Glenoid Component has been discontinued.

Based on these findings, Lima Orthopaedics Australia is of the view that the L2 liner is not performing as well as the original L1. As a result, only L1 components have been available since 6 August 2012.
