Fw: Web publishing request - Four joint implant web statements
[DLM=For-Official-Use-Only]

In relation to issues with the Apex K2 Modular Hip Replacement System, the Durom Acetabular Component, The Birmingham Hip Modular Head (BHR), and the SMR L2 Metal Back Glenoid Component 1, as delegate of the Secretary for the purposes of section 61 of the Act, approve under section 61(7) of the Act the release to the public of the therapeutic goods information relating to these actions as set out below.

SMR L2 Metal Back Glenoid Component (used in shoulder replacements)—product discontinued

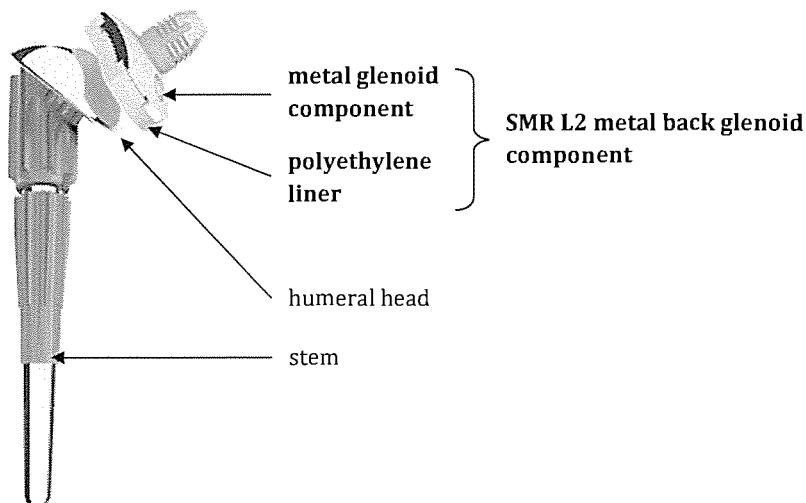
The metal glenoid component and polyethylene liner together comprise the SMR L2 Metal Back Glenoid Component (see diagram below).

The TGA advises health professionals and patients that the SMR L2 Metal Back Glenoid Component has been discontinued. Data collected by the Australian National Joint Replacement Registry (NJRR) revealed that the SMR had a higher than expected revision rate. The TGA contacted Lima Orthopaedics Australia, whose subsequent investigations revealed that under certain conditions, for example: rotator cuff failure or patient trauma, the SM L2 Metal Back Glenoid Component's polyethylene liner could become detached from the glenoid component, and that this had increased the revision rate of the SMR. As a result, the SMR L2 Metal Back Glenoid Component has been discontinued.

Lima Orthopaedics Australia has monitored the performance of the L2 component since introduction and has found that the total revision rate of the component in Australia is 6.78% at 3 years.

Based on these findings, Lima Orthopaedics Australia is of the view that the L2 liner is not performing as well as the original L1. As a result, only L1 components have been available since 6 August 2012.

Given the nature of the problem, there is no urgent need to contact patients who have received an L2 version of the SMR Metal Back Glenoid Component. However, it is recommended that those patients be followed up according to their routine protocol and advised of this issue at that stage.

If a patient presents with pain, a limited range of motion and/or complaining of a 'squeaking', 'clicking' or 'grinding' sensation at the site of their shoulder replacement, assess the component and follow your established protocols.

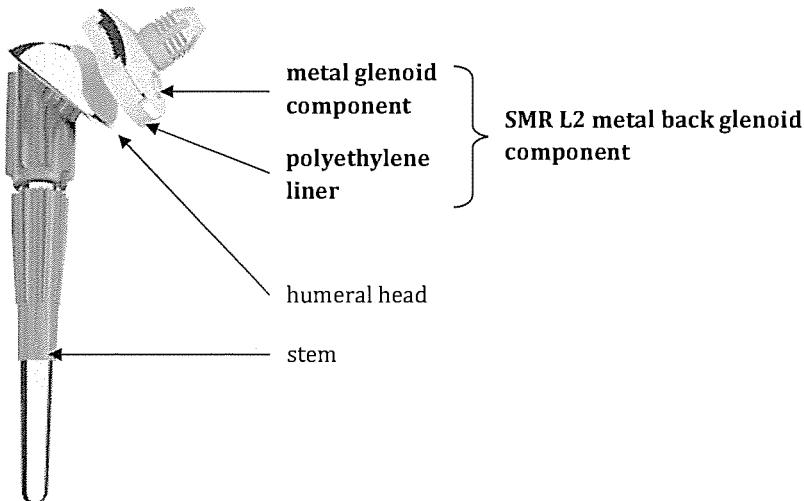
The metal glenoid component and polyethylene liner together comprise the SMR L2 Metal Back Glenoid Component (see diagram below).

The TGA advises health professionals and patients that the SMR L2 Metal Back Glenoid Component has been discontinued. Data collected by the Australian National Joint Replacement Registry (NJRR) revealed that the SMR had a higher than expected revision rate. The TGA contacted Lima Orthopaedics Australia, whose subsequent investigations revealed that under certain conditions, for example: rotator cuff failure or patient trauma, the SM L2 Metal Back Glenoid Component's polyethylene liner could become detached from the glenoid component, and that this had increased the revision rate of the SMR. As a result, the SMR L2 Metal Back Glenoid Component has been discontinued.

Lima Orthopaedics Australia has monitored the performance of the L2 component since introduction and has found that the total revision rate of the component in Australia is 6.78% at 3 years.

Based on these findings, Lima Orthopaedics Australia is of the view that the L2 liner is not performing as well as the original L1. As a result, only L1 components have been available since 6 August 2012.

Given the nature of the problem, there is no urgent need to contact patients who have received an L2 version of the SMR Metal Back Glenoid Component. However, it is recommended that those patients be followed up according to their routine protocol and advised of this issue at that stage.

If a patient presents with pain, a limited range of motion and/or complaining of a 'squeaking', 'clicking' or 'grinding' sensation at the site of their shoulder replacement, assess the component and follow your established protocols.
