**Australian Government**  
**Department of Health and Ageing**  
**Therapeutic Goods Administration**

## **SMR L2 Metal Back Glenoid Component (used in shoulder replacements)**

**Product discontinued**

**30 October 2012**

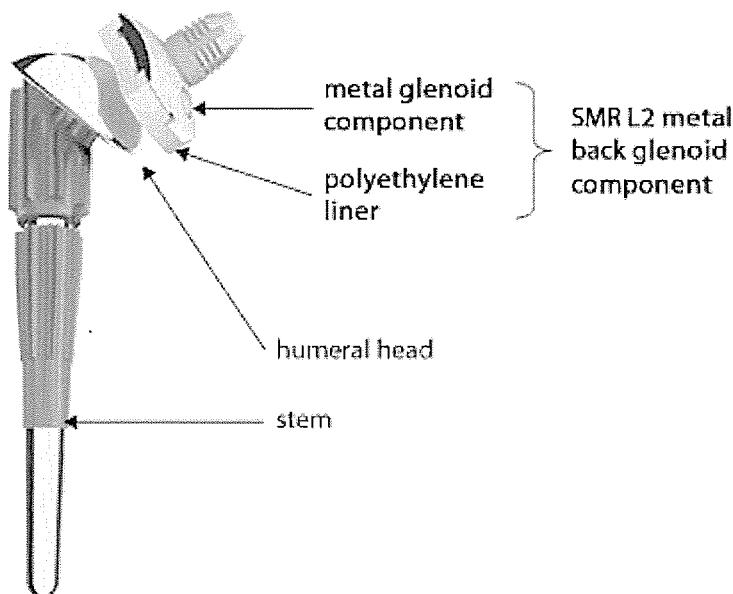
The metal glenoid component and polyethylene liner together comprise the SMR L2 Metal Back Glenoid Component (see diagram below).

The TGA advises health professionals and patients that the SMR L2 Metal Back Glenoid Component has been discontinued. Data collected by the Australian National Joint Replacement Registry (NJRR) revealed that the SMR had a higher than expected revision rate. The TGA contacted Lima Orthopaedics Australia, whose subsequent investigations revealed that under certain conditions, for example: rotator cuff failure or patient trauma, the SM L2 Metal Back Glenoid Component's polyethylene liner could become detached from the glenoid component, and that this had increased the revision rate of the SMR. As a result, the SMR L2 Metal Back Glenoid Component has been discontinued.

The L2 was introduced in 2009 in response to concerns that the polyethylene liner in the L1 version could wear down and lead to metal-on-metal contact. Subsequently, very few cases of polyethylene wear have actually been observed with the L1 design.

Given the nature of the problem, there is no urgent need to contact patients who have received an L2 version of the SMR Metal Back Glenoid Component. However, it is recommended that those patients be followed up according to their routine protocol and advised of this issue at that stage.

If a patient presents with pain, a limited range of motion and/or complaining of a 'squeaking', 'clicking' or 'grinding' sensation at the site of their shoulder replacement, assess the component and follow your established protocols.
