# Medical Device Incident Investigations: Recommendations

DIR 14102

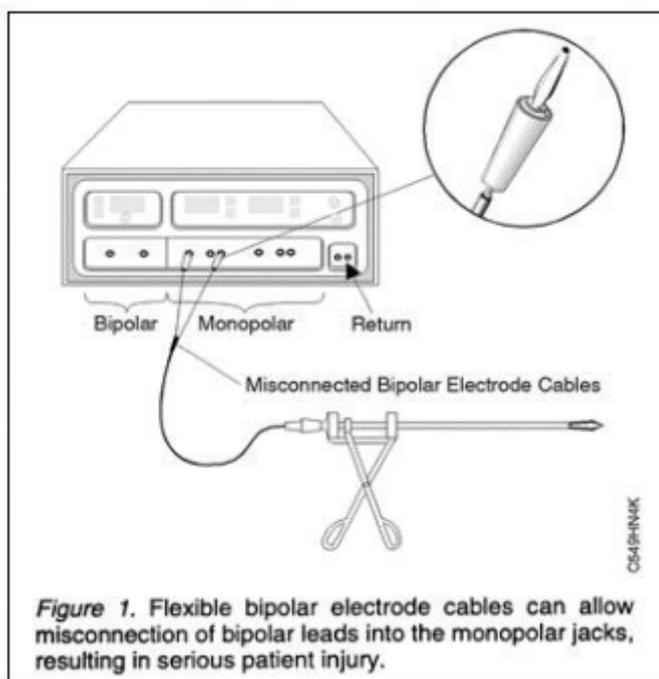
The TGA has recently received reports of experienced operating theatre staff misconnecting bipolar electrodes to electrosurgical unit (ESU) monopolar terminals. A literature review has revealed that serious adverse events associated with electrosurgical misconnection have also occurred abroad. The misconnection occurs when the two connectors of the bipolar electrode are accidentally plugged into two of the three monopolar terminals. It appears that this potential for misconnection exists with all brands of electrosurgical bipolar electrodes that have banana-type plugs mounted on flexible cables (see Figure 1).

When misconnected, the bipolar electrode may cause the ESU to inadvertently activate without operator initiation or control. If the monopolar power output has been programmed into the ESU (eg been left at its previous setting), the patient or operator can suffer serious burns or electric shock.

The activation mechanism for the hazardous monopolar current was described by Reeter in 1990: "The closed forceps short-circuit the ESU's switching circuit and turn on the monopolar current."<sup>1</sup> ECRI also published an article on bipolar electrode misconnection in 1993:

*If the bipolar electrode leads are plugged into the active monopolar jack and either one of the monopolar switching jacks, the ESU will be inadvertently activated when the tips of the bipolar forceps either 1) touch and short the leads together or 2) span the tissue with low enough impedance to permit activation.*<sup>2</sup>

Once activated the bipolar electrode will continue to hazardously discharge electricity until the electrode is unplugged or the ESU is turned off. Serious harm may occur during the time taken to deactivate the electrode.

1. Alert staff to the hazards of misconnecting the electrosurgical bipolar electrode to the ESU monopolar terminals. The greatest risk is presented to the patient and operator who may be exposed to uncontrolled electrosurgical current at monopolar power levels.

2. Ensure that the bipolar electrode is connected to the proper ESU terminals before operation.
3. Consider using bipolar electrodes that are designed to prevent misconnection.

4. Implement procedures that require the monopolar electrode to be plugged in before the return electrode (eg. thigh pad) is plugged into the ESU.
5. Implement procedures that require all ESU output/operating modes to be set to their minimum until the surgeon is ready to proceed in that mode. An output mode should remain at its minimum setting throughout an operating procedure until that mode is required. If an output mode is no longer required during a procedure it should be set to its minimum output.
