Medical Device Incident Investigations: Recommendations

Investigation of incidents with medical devices that have a 'memory' or an 'event log'

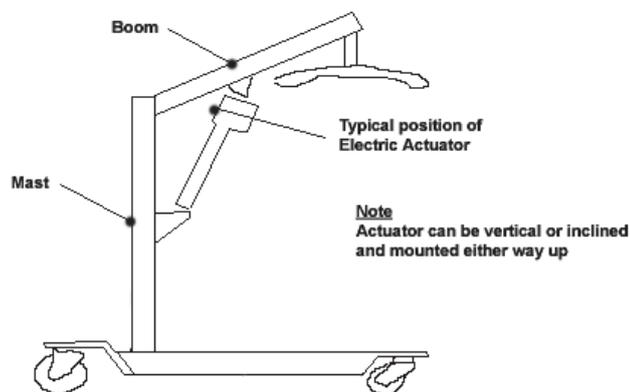
The TGA is aware of incidents involving electrically activated patient hoists which may fail without warning, causing the sudden dropping of the hoist boom, which could lead to patient and/or carer injury. This problem is also the subject of a safety warning from the Medicines and Healthcare products Regulatory Agency

Most incidents are related to damage and material fatigue caused by inappropriate handling, abnormal use and lack of proper servicing of the actuator mounting points. Excessive wear of the actuator mounting points can also lead to sudden failure of the actuator. The actuator failures are most influenced by usage, ie number of lifting cycles performed, rather than the age of the actuator. (Note: One lifting cycle = raising then lowering the patient.)

- Place patient hoists into the regular maintenance schedule for equipment in your healthcare facility. Welds, bolts, nuts, and strapping should be inspected regularly for signs of wear or damage.
- Identify mobile hoists with electric actuators, using the sketch below for guidance if necessary.

- Contact the hoist manufacturer, quoting the model and serial number, together with its rate of usage and age, to determine if the actuator is due for replacement.
- If the manufacturer cannot be contacted, for example because the hoist is unidentifiable or the manufacturer is no longer trading, a risk assessment should be carried out to determine if the electric actuator needs replacement.
