Medical Device Incident Investigations: Recommendations

Safety Alert: Abbott Medisense Optium Xceed Diabetes Monitoring System

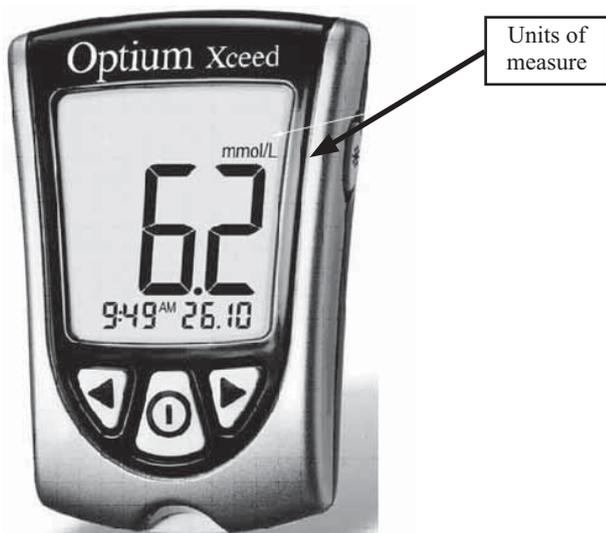
Turn on the meter and the unit of blood glucose measure will appear in the top right hand corner on the result review display screen. In Australia the meter should read mmol/L.

If the unit of measure is incorrect, please follow these steps:

- See the user manual for meter set-up instructions.
- Review the quick reference guide.
- Call the customer service department on 1800 801 478.
