Medical Device Incident Investigations: Recommendations

Safety Alert: Oxygen regulator fires resulting from incorrect use of CGA 870 seals

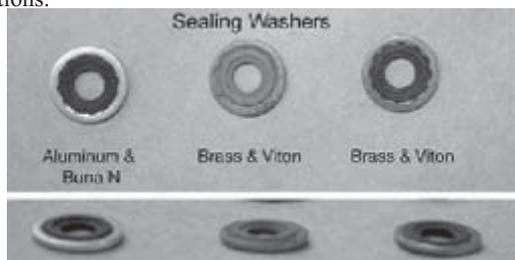
Figure 1. Examples of some recommended sealing washers available for CGA 870 style medical post valves designed for multiple uses

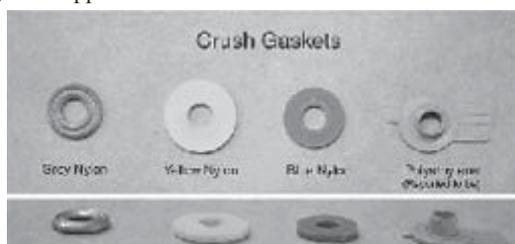
Figure 2. Examples of crush gaskets available for CGA 870 type medical post valves which should NOT be re-used.

When used more than once, the Nylon® crush gaskets require higher torque than the elastomeric sealing washers in order to seal the cylinder valve/regulator interface and, if they are used again, they require more torque with each successive use. The cylinder valve/regulator connection is designed to be hand-tightened. If the crush gaskets are re-used, the need for increased torque may require using a wrench or other hand tool, which can deform the crush gasket and damage the cylinder valve and regulator. This can result in leakage of oxygen past the cylinder valve seat and across the nylon crush gasket. According to a forensic analysis supported by the FDA and NIOSH, "flow friction" caused by this leakage of compressed oxygen across the surface of the crush gasket may produce enough thermal energy to spontaneously ignite the nylon gasket material.

The FDA and NIOSH recommend that plastic crush gaskets never be reused, as they may require additional torque to obtain the necessary seal with each subsequent use. This can deform the gasket, increasing the likelihood that oxygen will leak around the seal and ignite.
