# Medical Device Incident Investigations: Recommendations

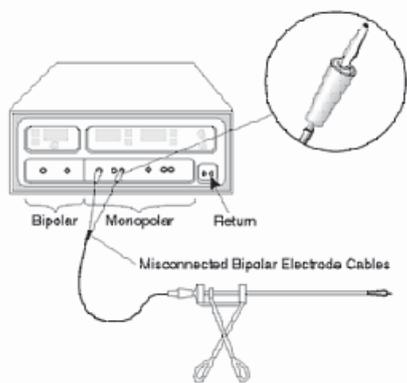
The TGA has recently received a report of an experienced operating theatre staff member misconnecting bipolar electrodes into an electrosurgical unit (ESU) monopolar terminals. A literature review has revealed that serious adverse events associated with electrosurgical misconnection have also occurred abroad. The misconnection occurs when the two connectors of the bipolar electrode are accidentally plugged into two of the three monopolar terminals. It appears that this potential for misconnection exists with all brands of electrosurgical bipolar electrodes that have banana-type plugs mounted on flexible cables (see Figure 1).

When misconnected, the bipolar electrode may cause the ESU to inadvertently activate without operator initiation or control. If the monopolar power output has been programmed into the ESU (eg been left at its previous setting), the patient or operator can suffer serious burns or electric shock.

Figure 1. Flexible bipolar electrode cables can allow misconnection of bipolar leads into the monopolar jacks, resulting in serious patient injury.

1. Alert staff to the hazards of misconnecting the electrosurgical bipolar electrode to the ESU monopolar terminals. The greatest risk is presented to the patient and operator who may be exposed to uncontrolled electrosurgical current at monopolar power levels.

2. Ensure that the bipolar electrode is connected to the proper ESU terminals before operation.
3. Consider using bipolar electrodes that are designed to prevent misconnection.
