# Medical Devices Safety Update

Volume 2, Number 3, May 2014

## Adjustments to plunger forces for new BD 50 ml Plastipak syringes

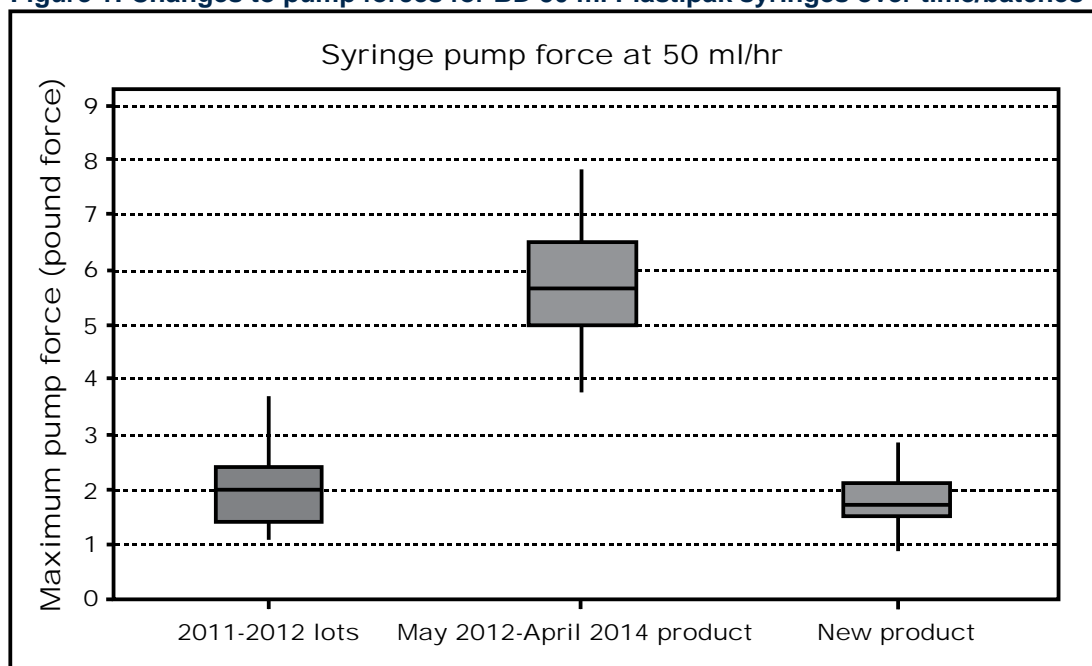
BD Plastipak 50 ml syringes with BD catalogue number 300865 supplied after 14 April 2014 and those syringes with BD catalogue number 300869 to be supplied from June/July 2014 will have similar plunger forces to products that were available before May 2012.

For the period May 2012 to April 2014, BD Plastipak 50 ml syringes supplied had higher plunger forces.

The changes to plunger forces in different lots over time is illustrated in Figure 1.

It is important that occlusion alarm settings be reviewed to ensure that the presence of lower friction forces within the syringe do not lead to a delay in detection and annunciation of an occlusion in the fluid delivery path, leading to possible adverse patient outcomes.

**Figure 1: Changes to pump forces for BD 50 ml Plastipak syringes over time/batches**

It is recommended that, once new 50 ml Plastipak stock has been received, occlusion alarm settings are returned to the original levels used before May 2012. New stock is identified by a prefix “N” ahead of the product number on the case and shelf pack labels, for example “N Ref 300865”.

Consult the syringe pump manufacturer’s service documentation to determine the appropriate way to verify and adjust occlusion alarm settings for your syringe drivers.
