INTERIM (DRAFT)

LABORATORY REPORT: DIR 25692

Poly Implant Prosthese (PIP) breast explants as per Device Incident Report (DIR 25692). Two implants were received - left and right breast - from Dr Pouw

DEVICE TYPE: SILICONE GEL FILLED BREAST IMPLANT

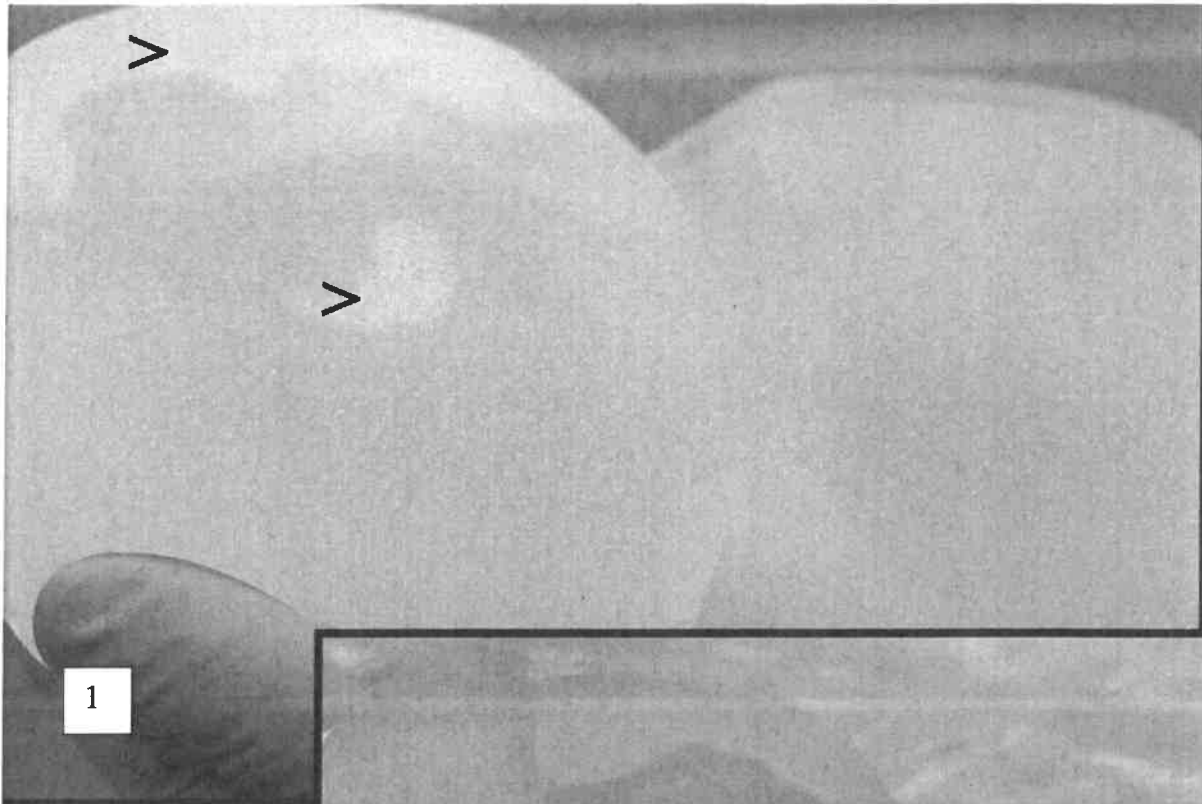
The implant is yellow in appearance has tissue residue on the patch side, easily removed with gentle rub. Implant has visible air pocket, but has no rupture, no perforation.

The implant is yellow but less yellow in colour than sample number 1202000756. The surface is clean and there is no evidence of tissue residue or wetness. There is no separation of the gel from the shell, no ruptures, no perforations.

- 1- Left and right implants as received showing difference in yellowing – Neither implant was ruptured but one showed signs of delamination of the shell from the gel (marked “>”)
- 2- Appearance of gel once the shell was peeled away both implants were similar.
- 3- Appearance of gel from a separate implant retrieval (more “cohesive” retained shape after peeling off the shell)

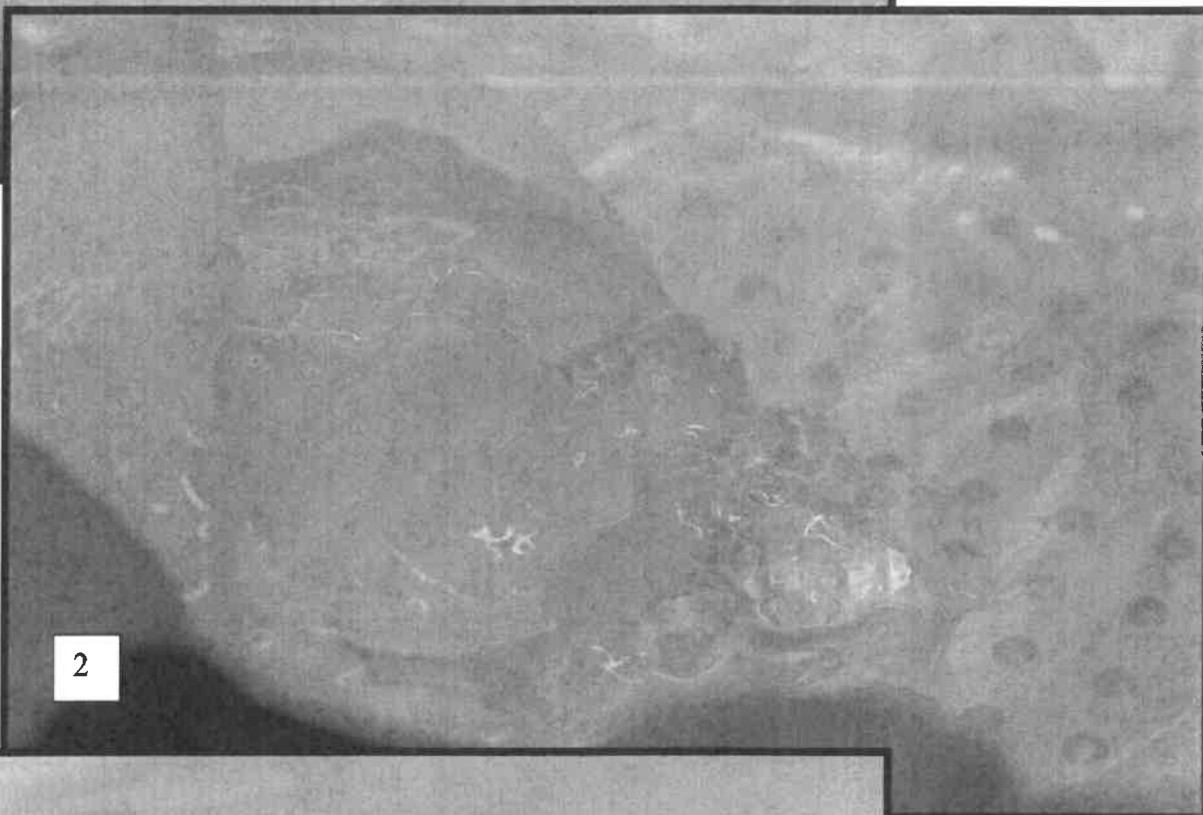
The Shell was cut and peeled away from the shell. The gel looks curdled and gummy and separates easily from the shell. The appearance of the gel is quite different to other implants observed to date. The appearance is like the gel has been "chopped up."

Most PIP gels examined to date hold the shape of the implant when the shell is peeled away and remain cohesive. Sample number 1202000756 does not retain the shape of the implant when the shell is peeled away and is "runny".

The Shell was cut and peeled away from the shell. The gel looks curdled and gummy and separates easily from the shell. The appearance of the gel is quite different to other implants observed to date. The appearance is like the gel has been “chopped up.”

The appearance may be explained by mechanical damage during implantation. The TGA should check with reporting surgeon when the implants were put in, the reason it was taken out and any other information that may explain the appearance of the gel.
