Ultrasound example of 73 yo with malignant tumour in left breast at 12 oclock.

SAFE BREAST IMAGING PTY LTD

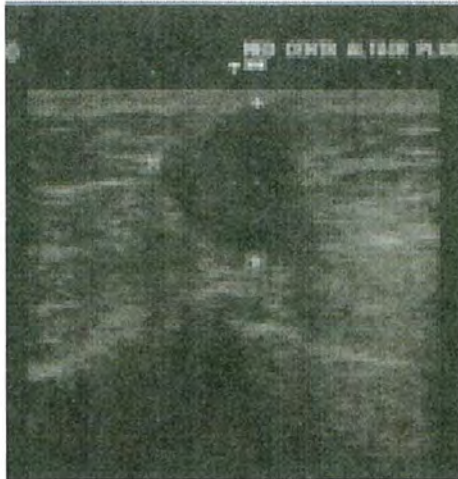
19×20×16 mm

- irregular shape
- blurred contours
- hypoechoic patchy structure
- hyperechoic inclusions of various dimensions
- acoustic shadow

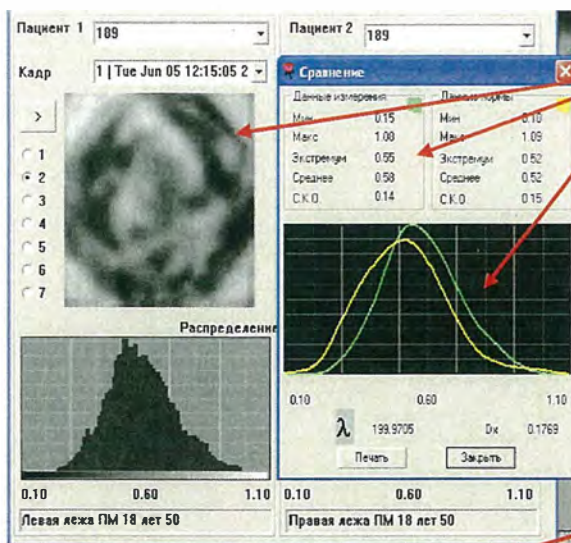
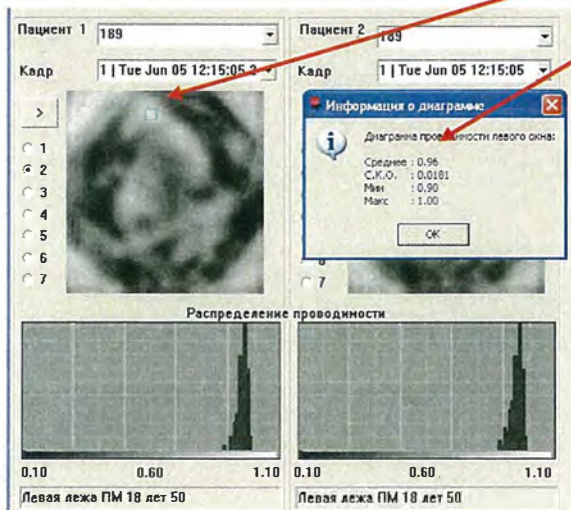
MEM analytical tools showing malignant tumour at 12 oclock in left breast of 73yo woman

Mean electrical conductivity of the left breast is 0.58, which corresponds to the age norm.

Electroconductivity in the zone of the malignant tumour location is 0.96.

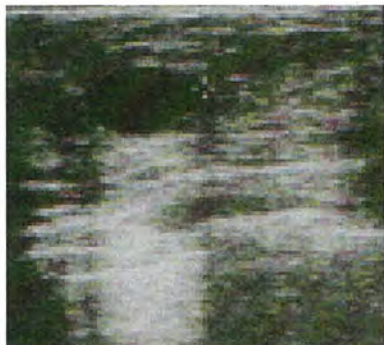
Ultrasound example of 39 yo with cyst in right breast at 10 oclock

- oval form
- absence of reflection from internal contents
- distal echancement
- well-defined differentiation between internal and external contours
- bright posterior wall
- symmetrical lateral acoustic

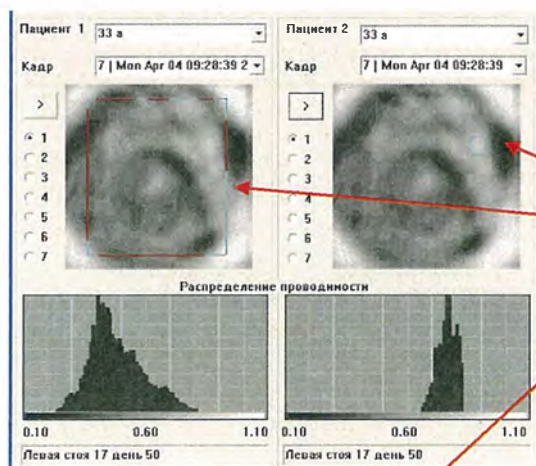
MEM example of same 33 yo showing fibroadenoma in left breast at 2 o'clock down three layers of scanning

Electroconductivity of the Fibroadenoma 0,65 against background of mean electroconductivity of 0,48, which corresponds to the age norm.

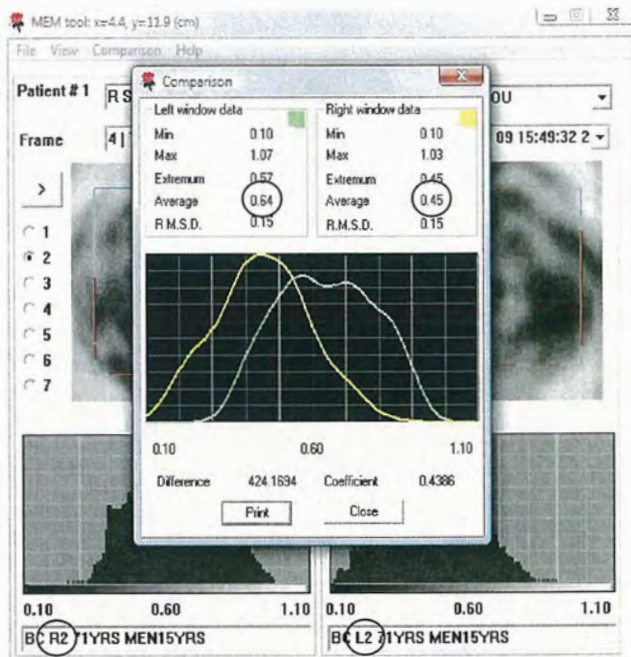
Example of 71yo, post-menopause 15 years with suspicious mass (Slide 2)

Comparison right and left breast.

Right breast in green, left breast in yellow.

Right breast higher conductivity than left, and irregular histogram shape.

Average conductivity of right breast is 0.64, compared to 0.45 for left.
